**BUILDING EVALUATION**  
**OF**  
**213 BROADWAY STREET and**  
**516 RIGSBEE AVENUE**  
**DURHAM, NORTH CAROLINA**  
**FOR**  
**THE CITY OF DURHAM**  
**POLICE DEPARTMENT**  
July 17, 2002

On June 12, 2002 a team of Stantec architects and engineers visited the following buildings to perform a existing building evaluation as part of our contractual agreement with the City of Durham to provide programming and schematic design:

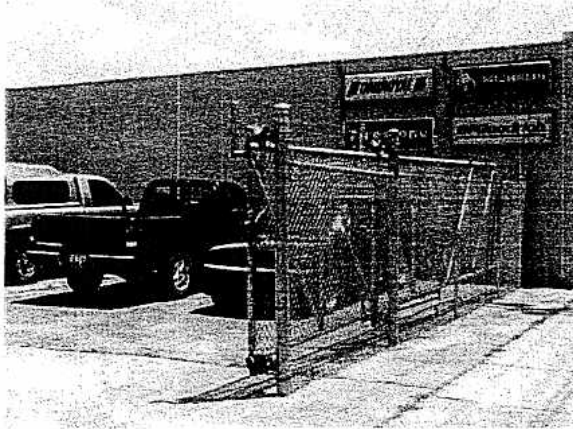
*Rigsbee Street Access*

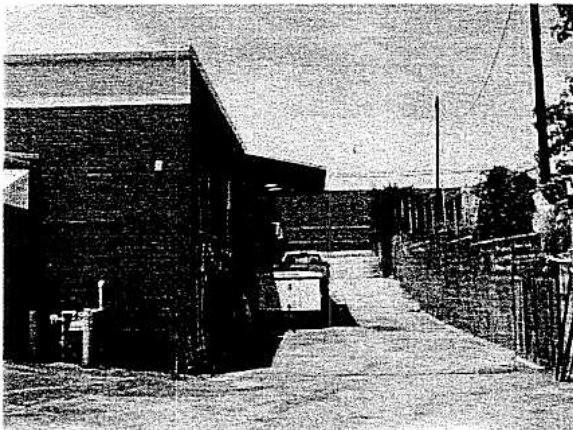
*Alley Drive to Broadway Street*

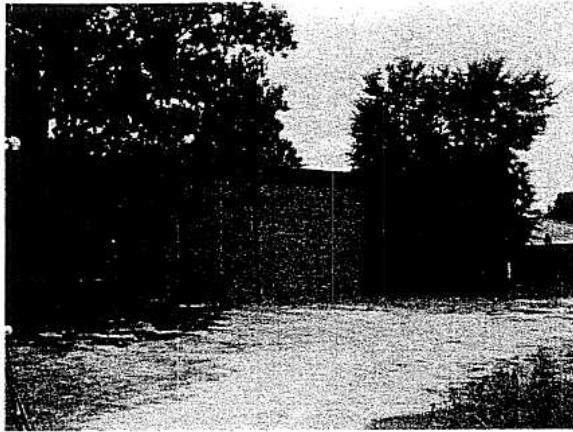
Three non-connecting parking areas serve the property. The entrances to each of these parking areas are gated. The existing concrete parking lot off Rigsbee Avenue to the south of the Rigsbee Avenue building is in good condition and is currently striped for 22 parking spaces.

*Owner should consider paving lot and providing access directly to the Broadway Street and Rigsbee Avenue Buildings.*

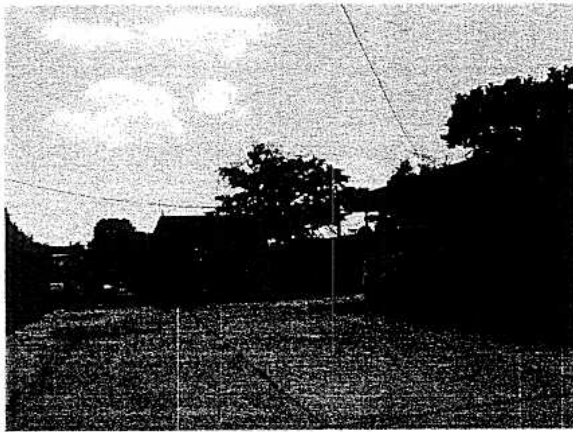
*Northeast view of Hunt Street entrance beyond covered shelter, loading dock and eastern parking lot. The pre-engineered storage building can be seen to the right of the covered shelter.*

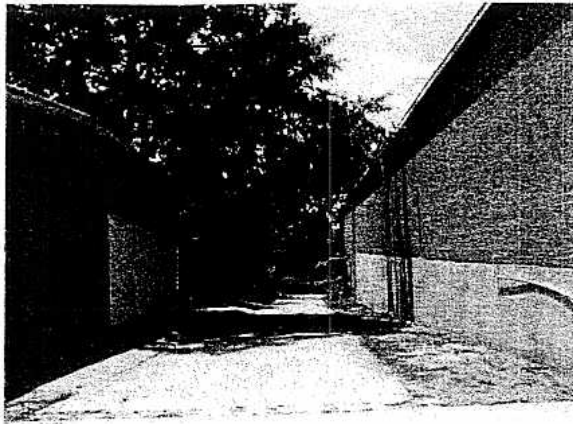
*East view of the alley with the pre-engineered storage building on the left.*

The alley behind (south) the 213 Broadway building could be used for vehicle storage. This alley runs 151 feet or the length of the building. Limited street parking is available along Broadway Street. Street parking is not available along Rigsbee Avenue. The existing on-site lots would accommodate 70 to 80 standard parking spaces. Handicap parking spaces may be required for site plan approval. The number of required parking spaces has not been determined. For Government buildings, the Durham City-County Zoning Ordinance states that the minimum number of required off-street parking spaces is "*based on review by the DRB considering site size, topography and supporting facilities.*" The exact number of required spaces requires further evaluation of the proposed improvements and coordination with City of Durham planning staff.

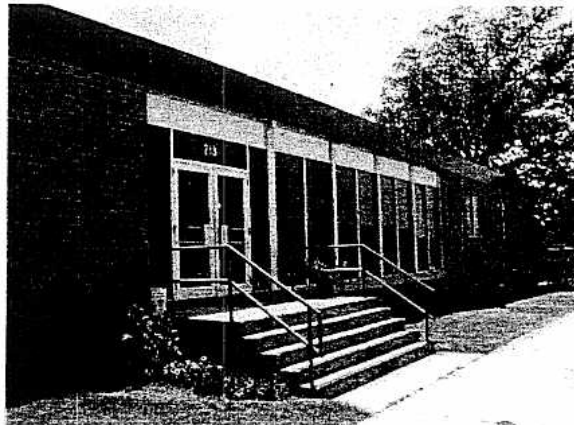
*Main entrance at north façade.*

The façade features a 2'-0" deep metal fascia panel band with utility brick masonry walls. Open head joints located near the base of wall allow water to pass out of the wall. The metal fascia panels appear to be in fair condition; however, caulked joints between panels have deteriorated and have possibly allowed water to pass into the existing wall. The panels should be re-caulked. It was observed that the existing metal fascia has bowed out from the exterior wall, which must be repaired. Evidence that water is entering the wall can be seen along the north-facing facade

where, existing lintels over windows have rust on surfaces and where deteriorated mortar joints can be seen along the base of the wall.

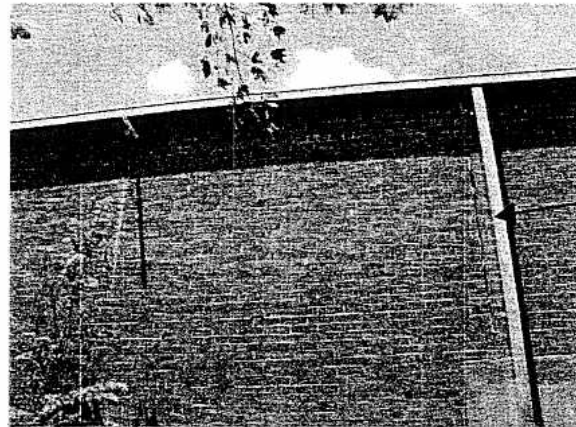
*Typical deteriorated control joint.*

The exterior walls are approximately 1'-0" thick and appear to consist of a double wythe utility brick. It is not clear if the existing wall is insulated or was designed with flashing and weeps holes. Control joints were observed along the west and south sides of the building; however, none were observed along the north and east façade. All control joints have deteriorated caulking that must be replaced.

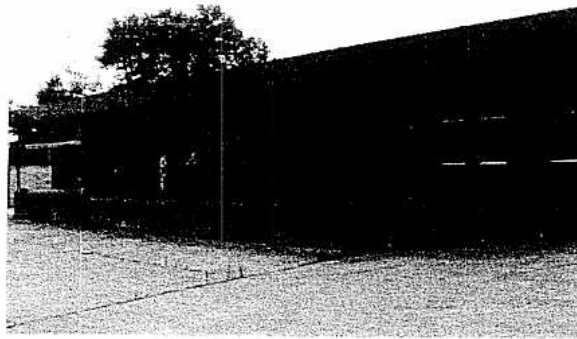
*Northeast view of loading dock.*

There is a covered loading dock located along the full length of the east side of the building. The structure consist metal decking over a network of exposed wide flange beams and bar joist supported by 4" diameter steel column and the exterior masonry wall. Rust was observed on all members, which should be removed and painted. An area where the existing metal roof deck has corroded away was observed, which must be repaired. Chicken wire has been hung from the underside of structure in order to prevent birds from nesting which will need to be replaced in order to gain access to the structure to apply a rust preventative and paint. The exterior metal fascia also has evidence of rust along the underside of the panels and some areas are bent, which need repair. There is access to a bathroom directly from the loading dock with one lavatory and one water closet. The loading dock and adjacent bathrooms are not required to meet Owner's programming needs. Owner may consider enclosing space in the future to be used as office or storage space. The loading dock has two uninsulated overhead doors which should be replaced with insulated units or openings be closed if adjacent interior space is to be conditioned.

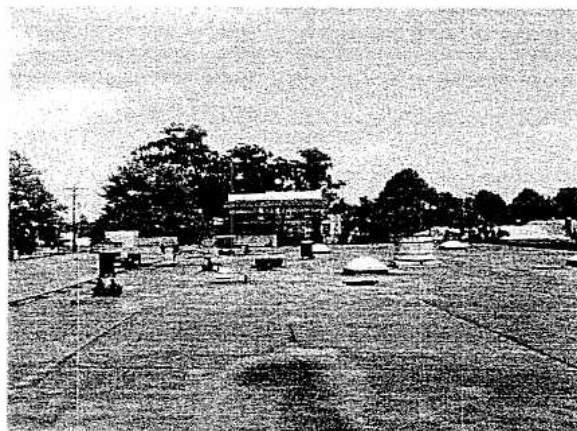
*Stained spots represent areas of ponding water.*

The existing roof consists of a single membrane mechanically attached Carlisle roof over tapered insulation. The roof is penetrated by 6 skylights, HVAC ducts, plumbing vents and gas piping. The overall condition of the roof is good; however, areas of ponding water were observed and areas where the insulation is compressed and loose were observed. It is recommended that testing should be done to identify the cause of these problems; however, no areas of leaks in the interior were observed. Based on Carlisle's records, the building was re-roofed in 1999 by Hamilin Roofing Company for the previous building owner. A warranty for the roof currently exists; however, has not been transferred to the City of Durham. Transfer of the warranty would require a Carlisle technical representative to conduct an inspection for a fee and will require a transfer fee. Any non-warranty repair found would need to be repaired by an authorized Carlisle applicator. The perimeter of the roof is terminated by a metal gravel stop. The roof is sloped toward the south side of the building where a continuous aluminum gutter leads runoff to three downspouts. All downspouts discharge on grade except for the downspout located at the southeast corner of the building adjacent to the loading dock. This downspout discharges into what seems to be a storm drain. The gutter and downspout system appears to be adequate. The roof has no exterior ladder or interior roof scuttle access, which should be considered. Also, the roof does not have walk pads as recommended by the roof manufacturer leading from the roof access point to all HVAC equipment requiring service.

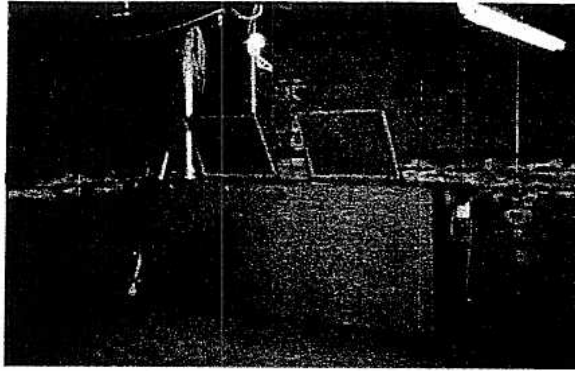
The building structure consists of a partial basement with a concrete slab, bearing concrete masonry walls supporting a network of steel beams and bar joist supporting the first floor composite metal deck/concrete slab assembly. The first floor consists of concrete slab ungrade and structural slab assembly over the Basement as previously noted. The roof consists of a membrane roof, tapered insulation, as noted above, a metal deck supported by a network of beams and bar joists supported by steel columns. The overall condition of the structure appears to be good; however, the North, East and West below grade walls have moisture problems.

*Efflorescence observed on basement walls.*

Efflorescence was observed along these walls and along the north wall where the floor decking has corroded. It can not be determined if the building foundation walls are waterproofed or if they an underground drainage system. Further investigations are required in order to determine the exact cause of water infiltration.

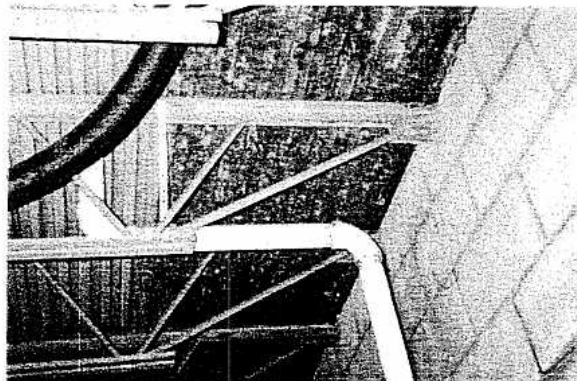
*Corroded decking observed at underside of first floor that must be repaired.*

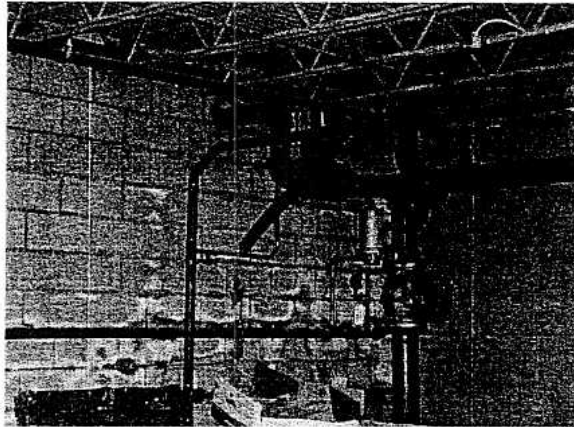
The entire building is protected by a wet, pipe-schedule fire sprinkler system. The system does not have main backflow flow prevention at this time.

*Six inch riser consist of a gate valve, alarm check valve with retard chamber and fire department connection.*

It is expected that the existing fire sprinkler system will require major modification. A six-inch backflow preventer will need to be installed at the riser. Because the existing system is an older pipe scheduled system using schedule 40 screwed pipe with  $\frac{3}{4}$ " pipe at the end of the branchlines, most if not all of the pipe and heads will need to be removed and replaced with a new hydraulically calculated system. The new piping will be designed for the new interior space layout.

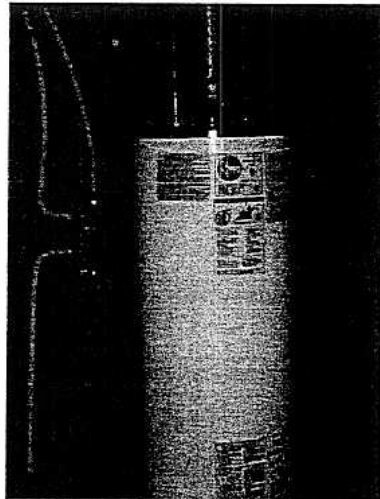
*This appears to be a 40-gallon residential type water heater.*

A single gas fired hot water heater is located near the existing boiler. The water heater seems in good condition, but may not be adequate for the building.

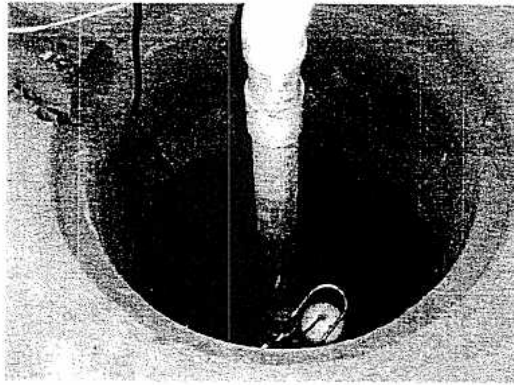
*Existing sump collects ground water from a 4" line entering the pit from under the main building and the discharge pipe goes up and through the exterior building wall.*

The pump probably needs to stay with an enclosure/protection designed.

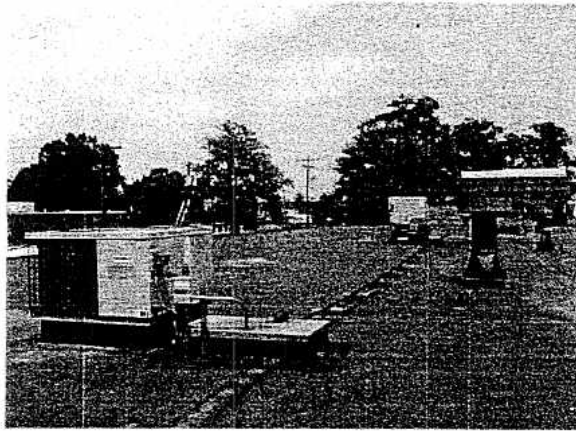
The 3-rooftop units have gas heat and are all 5 years old or less. The condensing units on the roof for the 3 split systems are also 5 years old. Gas heat is provided in each of the units. All 6 systems are ducted to the areas served. The units and inside ductwork

appear in good condition and reuse is recommended to the extent possible.

*HVAC condensing unit.*

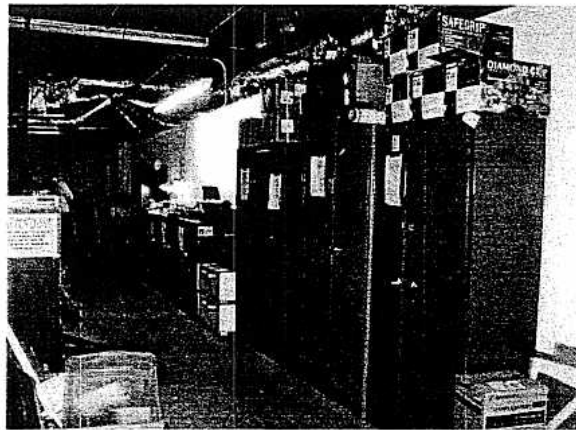
*Kinks and bends restrict the air flow should be eliminated. This increases pressure drop which increases energy use.*

The length of flex duct is overextended, which should be corrected.

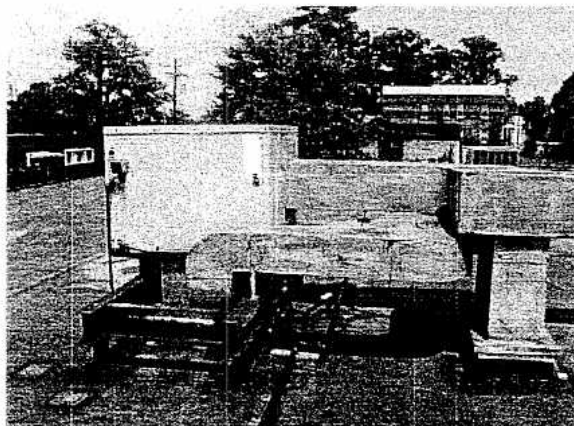
*On one rooftop unit the layout of exposed ducts loses a lot of system static pressure, which should be corrected.*
